# **DESTRUCTION OF THE KAKHOVKA RESERVOIR: ENVIRONMENTAL CONSEQUENCES**

**Destruction** of the Kakhovka Reservoir: Environmental Consequences (adapted translation from Ukrainian) / compiled by V. Kolodezhna and O. Vasyliuk. – Chernivtsi: Druk Art, 2026. – 112 pp. – (Series: *Metamorphoses of Velykyi Luh*, No. 4).

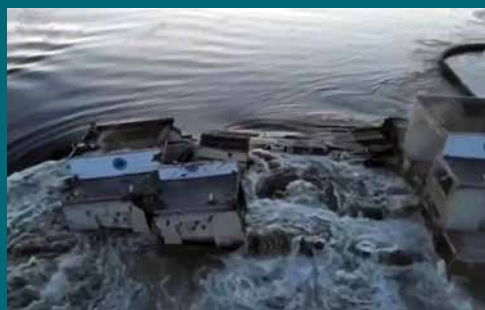
*Kakhovka HPP after its destruction  
by Russian forces (2023)<sup>[2]</sup>*

Hydropower dams are designed with substantial safety margins and are therefore virtually impossible to destroy by external shelling or aerial bombardment. Damage on the scale observed at the Kakhovka HPP dam could not have been caused by any form of external attack. Other major hydropower plants in Ukraine have

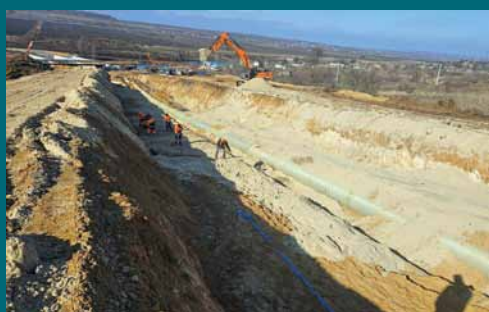
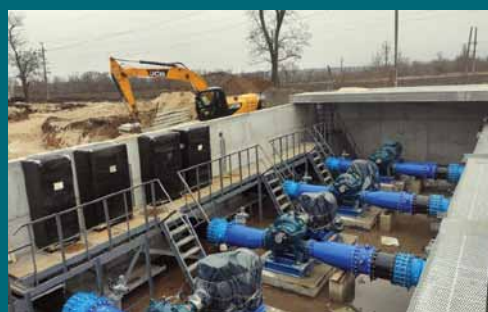
*Construction of the water pipeline and installation of chambers for the maintenance, inspection, and control of the pipeline network.*

Restoring water supply for the population became the principal priority for recovery in the affected areas<sup>5</sup>. Immediately after the terrorist attack by Russian forces on the Kakhovka HPP dam, the Government of Ukraine allocated approximately UAH 980.5 million<sup>[179]</sup> for the transportation of drinking water to the affected regions of Dnipropetrovsk, Zaporizhzhia, Mykolaiv, and Kherson.

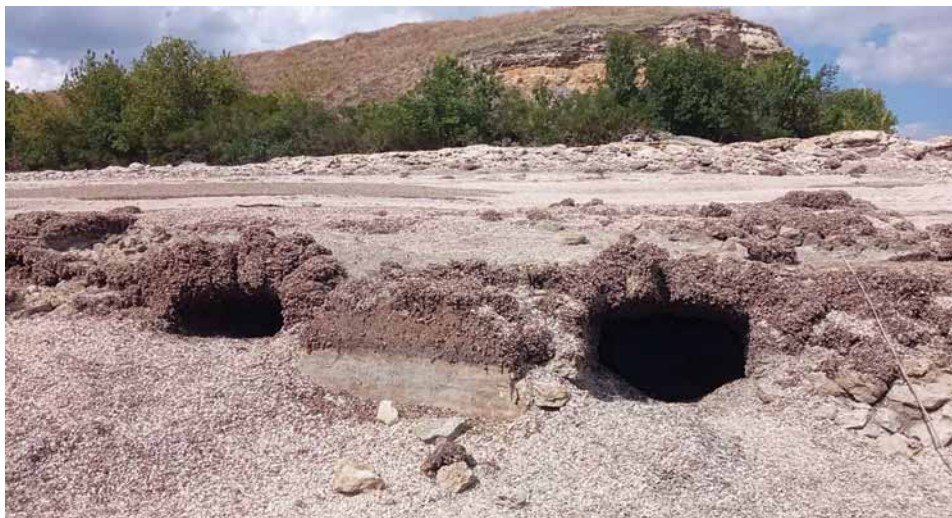
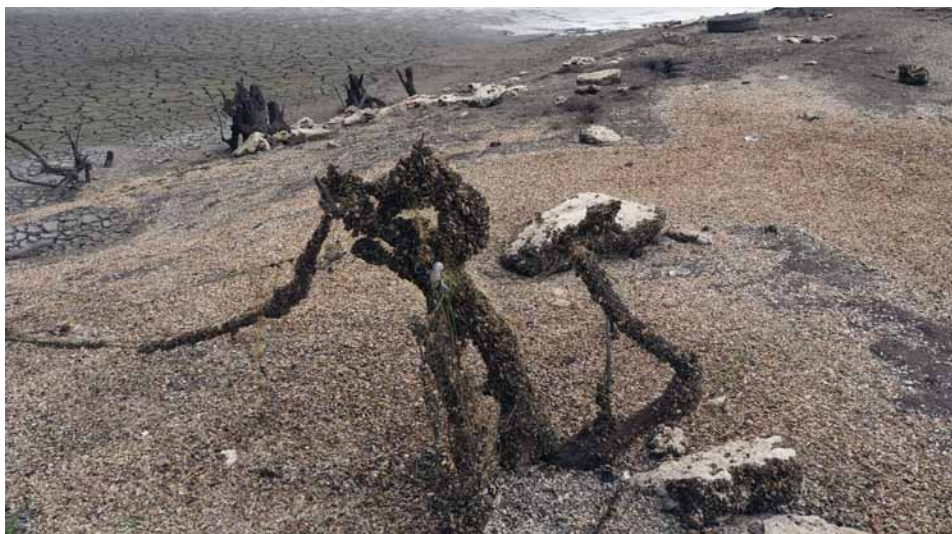
*Colonies of Dreissenid Mussels on the Reservoir Bottom and on Flooded Trees  
(photos by S. Skoryk and I. Moisiienko, respectively, 2023)*

In the future, the deposits of dead zebra mussels will play an important role in determining possible future uses of this area. On the one hand, these mussels were highly efficient water filter feeders (1 kg of zebra mussels can filter more than one ton of water per day). On the other hand, they accumulated pollutants within their tissues, which may be released over time if a new reservoir is created<sup>[140]</sup>. In addition, their shells form extensive colonies that may cover areas of tens of hectares, potentially creating a physical obstacle to the future use of the former reservoir bed.

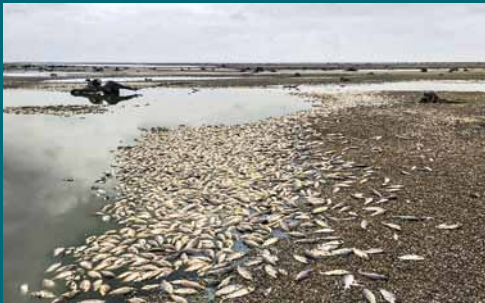
*Formation of Isolated Water Bodies During the Decline in Water Level in the Kakhovka Reservoir (photo by M. Bronziuk)*

One of the most visible consequences of the destruction of the Kakhovka HPP dam was the mortality of large numbers of freshwater fish, including juveniles, inhabiting the Kakhovka Reservoir and the floodplains of the Lower Dnipro. In particular, many fish became trapped as the reservoir water level declined and numerous isolated, non-draining water bodies were formed. Water levels in these water bodies continued to fall as water filtered through the layer of bottom sediments.

By the beginning of autumn 2023, five to eight large water bodies remained connected to the Dnipro River channel, 15-20 medium-sized and large water bodies that had lost their direct connection with the river, and a large number of isolated medium-sized and small water bodies<sup>[128]</sup>. In most of the smaller water bodies, the principal components of the aquatic ecosystem had probably already perished<sup>[128]</sup>.

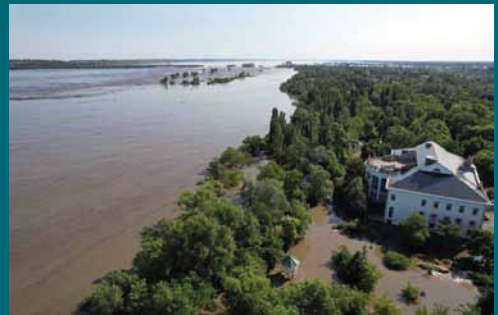
*Flooded Area of Lower Dnipro National Nature Park (photo courtesy of the archive of Lower Dnipro National Nature Park)*

The area most severely affected by the flooding was Lower Dnipro National Nature Park, where the water level rose by 3.5 m and remained at that level for more than ten days. The park was established to protect the Dnipro Delta as one of the most valuable floodplain and riparian complexes in Europe, which was completely flooded by the waters of the Kakhovka Reservoir<sup>[188]</sup>.

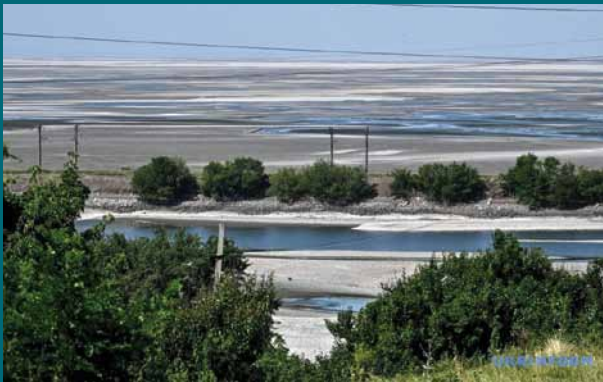
*View of the Kakhovka Reservoir after the Water Receded in June 2023 (photo by Ukrinform<sup>[220]</sup>)*

As the force of the water flow and the extent of flooding gradually decreased, the concentration of suspended sediments and pollutants continued to increase<sup>[96]</sup>. At this stage, sediments that

had accumulated on the bed of the Kakhovka Reservoir over decades, together with debris from destroyed infrastructure and waste disposal sites (including biological waste), became incorporated into the suspended load. Consequently, the most heavily contaminated deposits are likely to be the uppermost sediment layers – those deposited during the final stage of the flood.

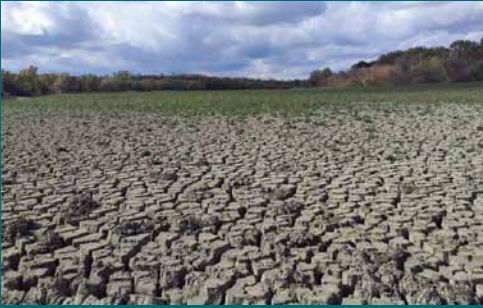
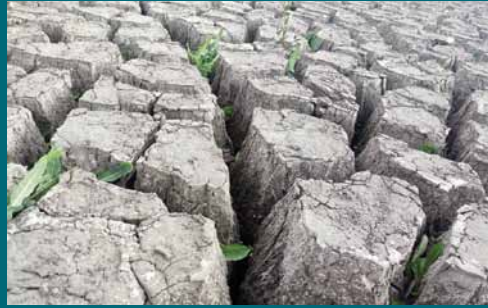
*Desiccation Cracks on the Bed of the Kakhovka Reservoir, 19 October 2023  
(photo by O. Khodosovtsev)*

Despite the cracked surface of the exposed reservoir bed and early predictions of desertification, the former reservoir is being naturally recolonized by vegetation. In areas where vegetation has not yet become established, the cracks facilitate soil formation by trapping windblown organic matter and plant debris, including leaves, twigs, and the remains and feces of detritivorous animals.

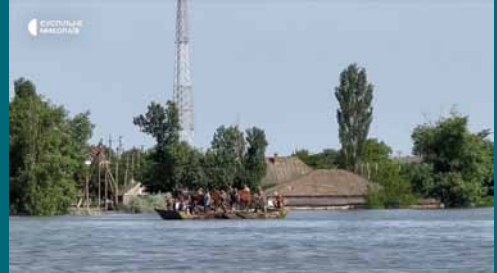
*Flooded Afanasivka Village, More Than 80 km from the Confluence of the Inhulets and the Dnipro (photo: Suspilne Mykolaiv<sup>[122]</sup>)*

The volume of water flowing from the Dnipro was so great that water levels also rose in its tributaries, the Inhulets and Viryovchyna rivers. Reverse flow was recorded in both rivers<sup>[145]</sup>. Water levels in the Inhulets River rose as far as 150 km upstream. The average increase in water level was approximately 6 m<sup>[88]</sup>, reaching up to 8 m in some places, while the flooded area covered about 67 km<sup>2</sup>. Because the Inhulets is a regulated river and lacks a well-defined floodplain, valuable steppe habitats on its slopes were affected by the flooding.

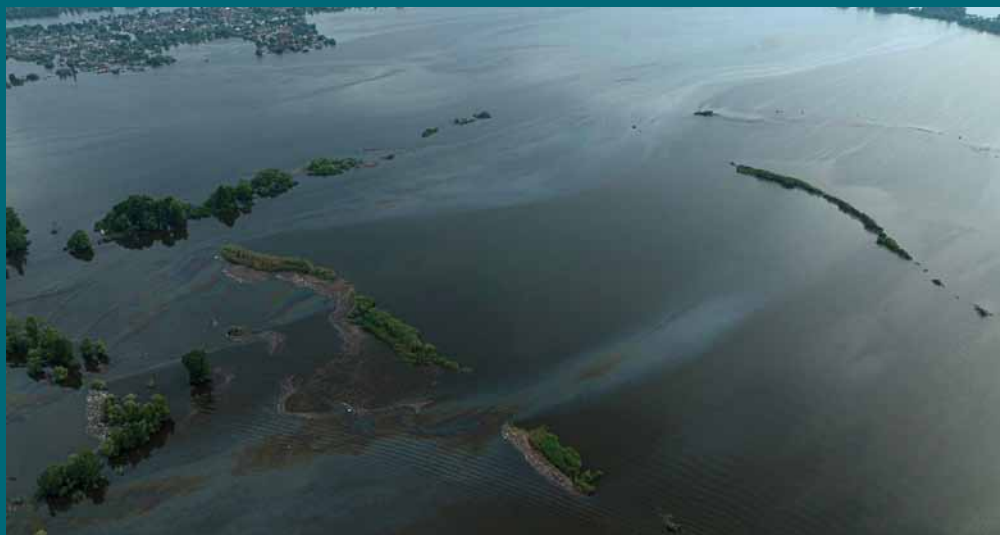
*Petroleum Products in the Flooded Area near the City of Kherson, 10 June 2023  
(photo: Keystone / AP Photo<sup>[107]</sup>)*

Water samples collected in late June 2023, from Odesa Bay, near the city of Ochakiv, the Dnipro–Buh estuary, and near the city of Kherson showed similar levels of contamination. Concentrations of petroleum products, toxic metals (Zn, Cd, and Pb), and organochlorine compounds (lindane and PCBs<sup>29</sup> <sup>[211, 216]</sup>) exceeded permissible levels.

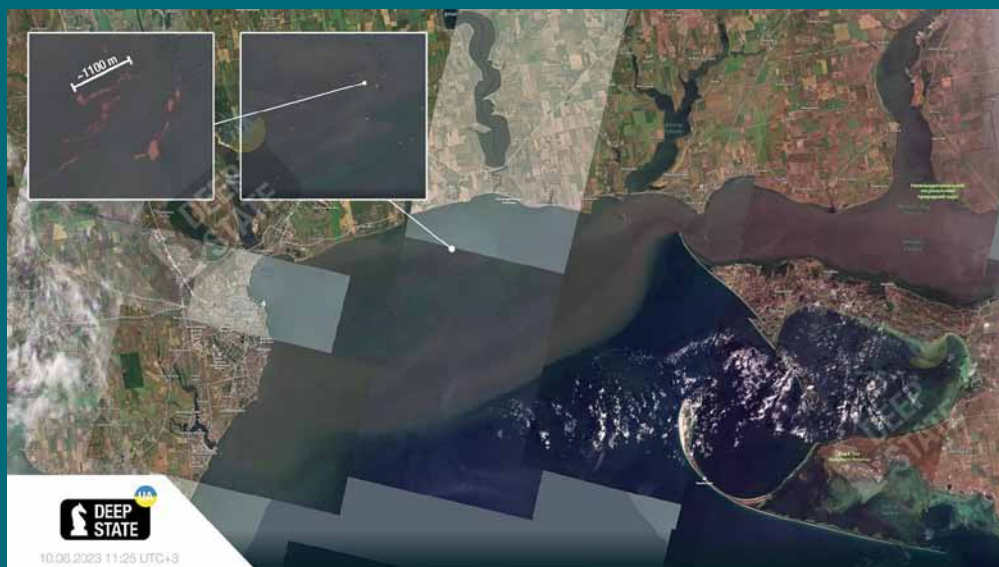
*"Islands" of Debris Recorded in the Black Sea on 10 June 2023 (source: DeepState)*

On the third day after the disaster, when the polluted waters reached the Odesa coastline (9 June), concentrations of petroleum products in the Black Sea near the village of Nova Dofinivka exceeded the permissible level by a factor of 6.6, while iron concentrations were up to 12.4 times above the permissible level. Elevated concentrations of ammonium nitrogen were also recorded<sup>[142]</sup>. These most likely resulted from the decomposition of organic matter and probably entered the water following the flooding of sewage systems, cesspits, and agricultural facilities.

Petroleum products covering large areas of the sea surface caused oxygen depletion, leading to the suffocation of marine organisms, while elevated nitrogen concentrations accelerated the growth of phytoplankton.

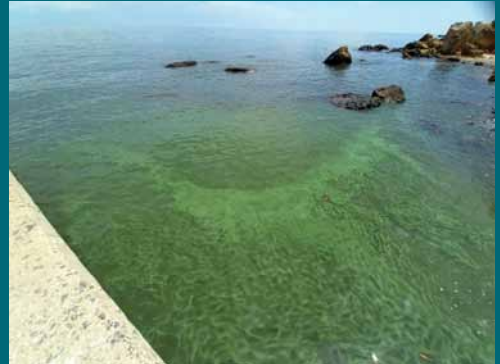
*Intensive Phytoplankton Bloom in Desalinated Seawater in Odesa Bay, 14 June 2023  
(photo by O. Halaiko<sup>[222]</sup>)*

Water blooms were first recorded in the coastal waters of Odesa on the eighth day after the disaster, 14 June 2023. Freshwater and brackish cyanobacteria, which are naturally present in Odesa Bay, dominated the bloom; however, their abundance was exceptionally high. Particularly abundant were *Aphanizomenon flos-aquae* and *Microcystis aeruginosa* (3 g/m<sup>3</sup>), which formed a green film on the water surface. Phytoplankton biomass increased by 150-300 times<sup>[33, 212]</sup>, and in some areas by as much as 2,000 times<sup>[121]</sup> compared with normal levels.

Peak development of the phytoplankton bloom was recorded on 25 July 2023, when it covered 32,450 km<sup>2</sup> of the Ukrainian sector of the Black Sea<sup>[162, 212]</sup> – an area 16 times larger than the former Kakhovka Reservoir.

Intense phytoplankton blooms reduce light penetration into deeper water layers, suppressing the development of benthic organisms. The seasonal die-off and subsequent decomposition of phytoplankton increase biochemical oxygen demand (BOD<sub>5</sub>), leading to oxygen depletion, similar to the processes observed in the Dniro reservoirs during cyanobacterial blooms. This results in the mortality of sessile and planktonic organisms<sup>[216]</sup> and forces fish to migrate.

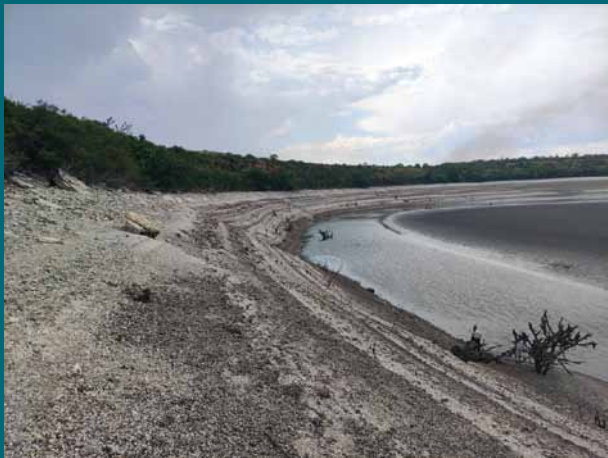
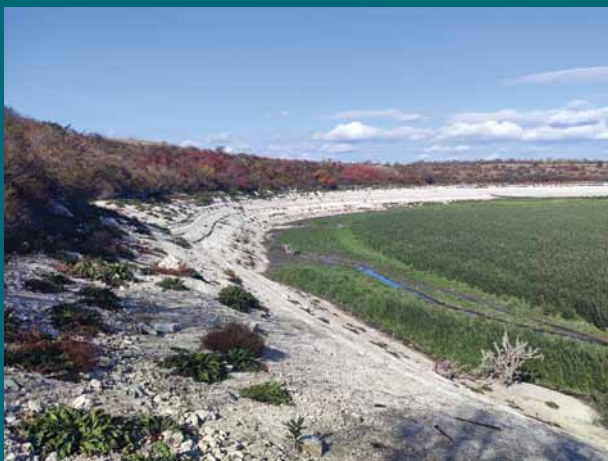
*General View of the Bed of the Former Kakhovka Reservoir in the Drained Respublikhanets Bay, Kamianka Ravine, on 30 June and 19 October 2023 (photo by O. Khodosovtsev)*

During the first field surveys, conducted on 30 June 2023 (three weeks after the dam's destruction) and again on 19 October 2023 (three and a half months later), researchers observed rapid vegetation recovery. **Four habitat types had already begun to develop<sup>[21]</sup>: willow thickets, wetland habitats, sparsely vegetated areas, and areas covered with dead mollusc shells.** In June 2023, only 10 species of vascular plants were recorded within the surveyed areas of the former reservoir, whereas by October this number had increased to 68. Of the recorded species, only 16 were non-native, and none had become dominant<sup>[71]</sup>.

By the end of June 2023, the surveyed areas of the former reservoir bed were already densely covered with willow seedlings, with an average density of 90 individuals per square meter. Three months later, extensive willow thickets covered large areas of the former reservoir bed<sup>32</sup>. During this period, the average height of willows increased from 50 cm to 190 cm, corresponding to a mean daily growth rate of 1.7 cm. The tallest individuals reached 309 cm, indicating highly favorable conditions for the development of gallery willow forests. This prediction was confirmed in October 2024, when the average height of willows at the study sites reached 4.66 m, with the tallest measured individual reaching 5.46 m<sup>[154]</sup>. The structure of the willow stands also became substantially more complex. During their first year, they consisted of a single vegetation layer, whereas by the second year they had developed distinct tree regeneration, shrub, herbaceous, and moss layers.

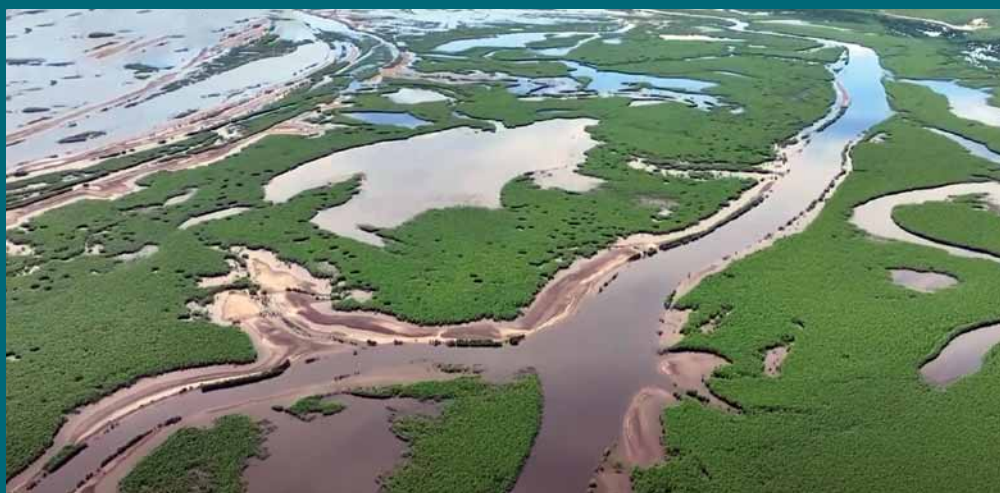
*Mosaic of Forest and Wetland Habitats on the Bed of the Kakhovka Reservoir near Chervonohryhorivka, June 2024 (photo: State Border Guard Service of Ukraine)*

Field expeditions conducted in 2024 confirmed that the young forest habitats had successfully survived the winter and continued to grow. As the biomass and density of the vegetation cover increased, the area occupied by vegetation in the central part of the former reservoir also continued to expand. Satellite imagery from June 2024<sup>[79]</sup> clearly shows that the proportion of open areas had decreased substantially, while the proportion covered by vegetation had increased. At the same time, the bed of the former Kakhovka Reservoir still contains areas with muddy, takyr-like substrates, as well as areas covered by shell deposits formed from the shells of dead molluscs. These areas are revegetating slowly but are gradually being shaded by trees, which are expanding their crowns over them. As a result, the area covered by vegetation continues to increase, while the shade

created beneath the trees increases the likelihood that other plant species will become established.
